# Manhole Inspection Summary

Manhole # S11MM\_021MH

Insp Date: **1/21/09 10:23 AM**

**Location** Address: **POPLAR TER**

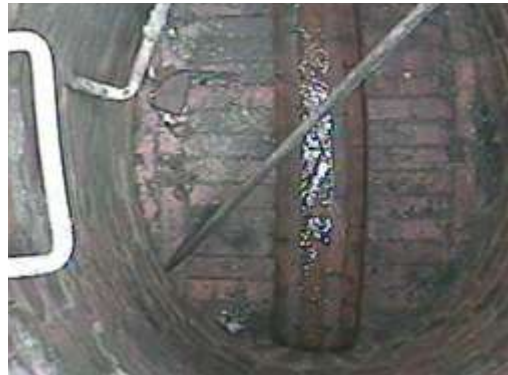
Top View

DEBRIS ON BENCH

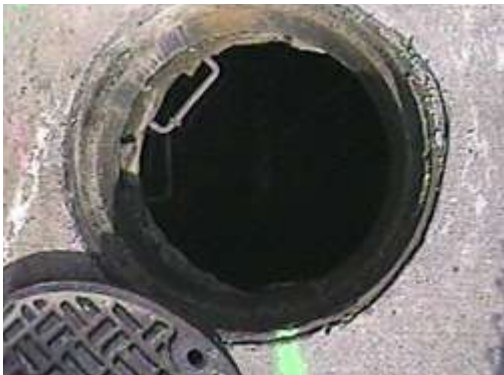
Top View

**Frame** Offset: **3** (in.) Condition: ☒ Sound ☐ Cracked ☐ Leaks

FRAME OFFSET

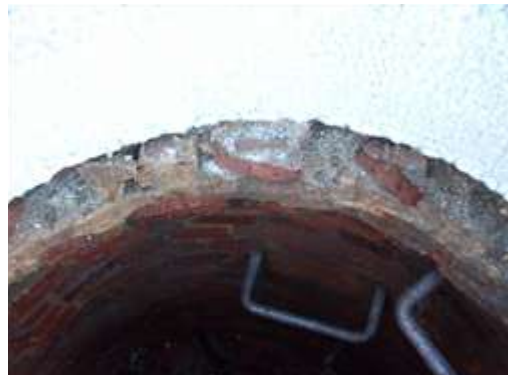
Defect 1

**Chimney / Frame Adjustment** ☒ Exists Material: **Brick and Concrete** ☐ Parged Height: **3** (in.)

Condition: ☐ Sound ☒ **Cracked** ☐ Root Intrusion ☐ Loose Brick ☐ Deteriorated

CRACKED CHIMNEY/FRAME  
ADJUSTMENT

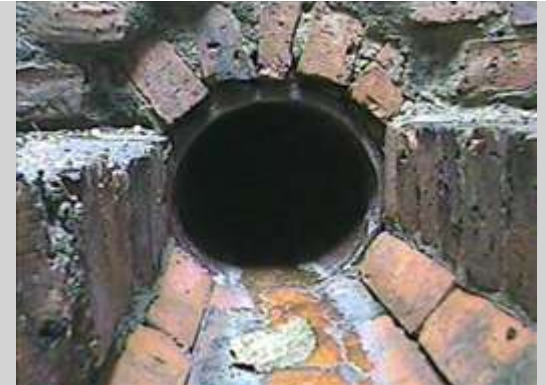
12 O'Clock Outflow

8 in. Circular Gravity Sewer  
Pipe Out @ 12 O'Clock

Pipe Height: (in.) Direct  
Pipe Material: **Clay** ☐ Pipe Lined  
Invert Depth: **6.11** (ft.) Flow Characteristics: **Slow**  
Deposits: ☒ None ☐ Mud ☐ Sludge ☐ Debris ☐ Grease  
Silt Depth: (in.) Deposits Extent:  
Infiltration: **None** Pipe Seal Cond: **Sound**

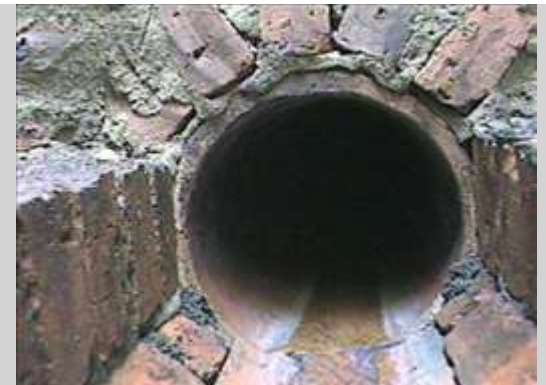
6 O'Clock Inflow

8 in. Circular Gravity Sewer  
Pipe In @ 6 O'Clock

Pipe Height: (in.) Direct  
Pipe Material: **Clay** ☐ Pipe Lined  
Invert Depth: **6.13** (ft.) Flow Characteristics: **Slow**  
Deposits: ☒ None ☐ Mud ☐ Sludge ☐ Debris ☐ Grease  
Silt Depth: (in.) Deposits Extent:  
Infiltration: **None** Pipe Seal Cond: **Sound**
